# FILIA VISUAL

## **VISUAL STATEMENT FOR THE CLANWILLIAM DAM RAISING PROJECT**

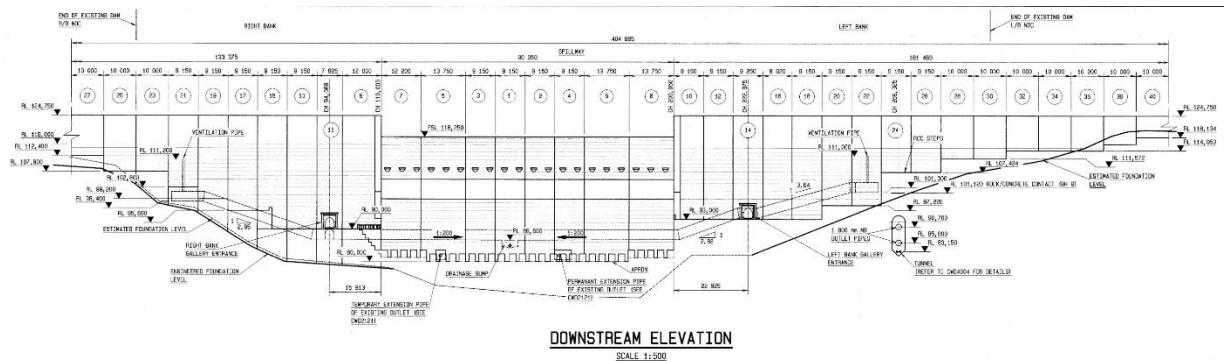
It should be noted that the VIA does not make mention of the intake tower illustrated in Figure 23 above. This structure, although it does not raise the overall level of the dam wall, was either not part of the design at the time of the writing of the VIA, or it was overlooked as a visible element requiring mitigation. See Condition 1 & 2 for further detail.

**Figure 23: Downstream elevation of the approved Dam wall raising (Department of Water and Sanitation, 2017)**

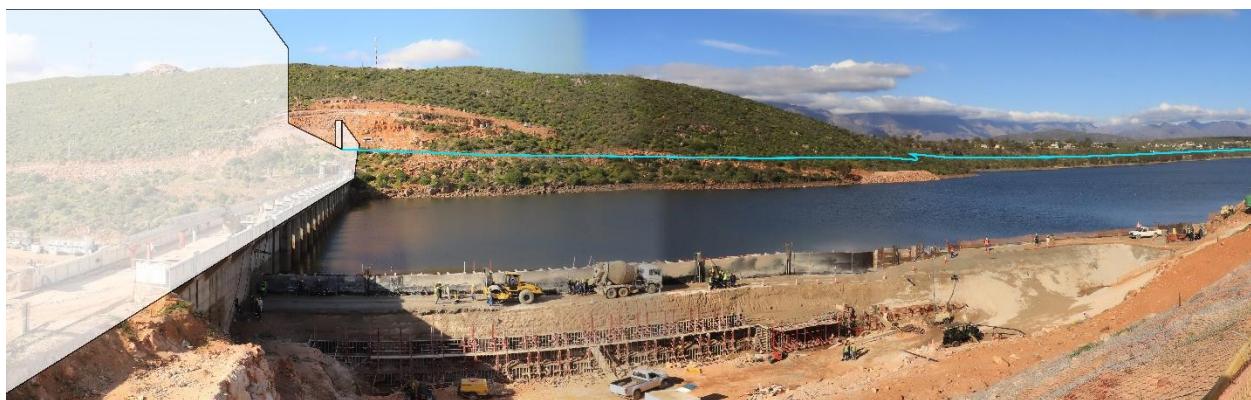
**Figure 24:** Diagrammatic simulation of the FSL after completion of the works, as viewed from the existing construction road on the level of the old N7, looking south east across the water towards Ramskop Nature Reserve and the concentration of visual receptors on the eastern bank (Smit, 2025)

Figure 24 above is a diagrammatic representation of the FSL and the proposed dam wall that approximates the height and point of contact on the eastern bank. The reason for the extensive vegetation clearing and earthworks undertaken in this area is unclear, given the estimated final height of the dam wall, and the apparent lack of other infrastructure proposed in this area (see Figure 21 for plan view). The building mass of the intake tower is not illustrated in this simulation because the viewer is located within its proposed footprint.

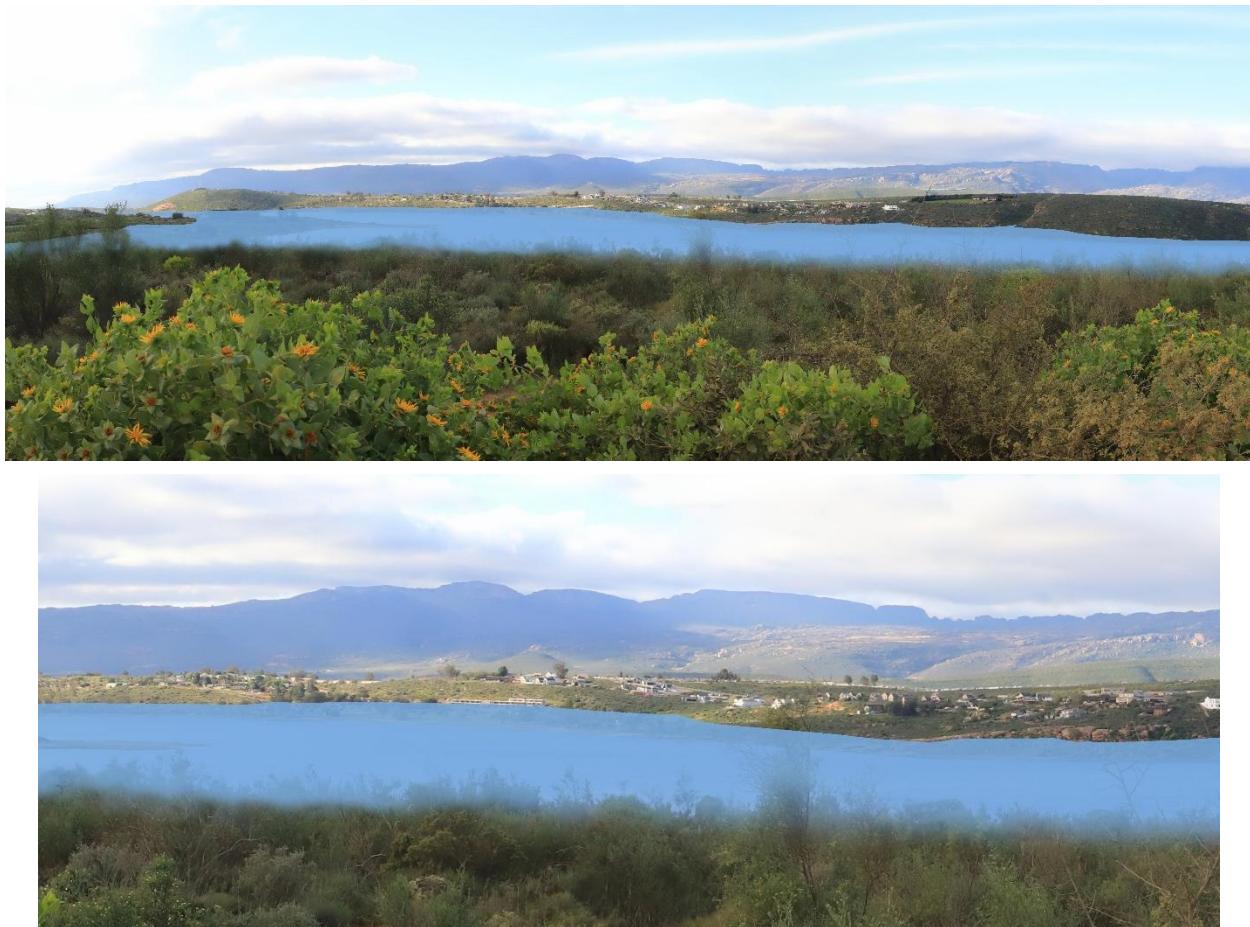
**Figure 25:** Diagrammatic simulation of the FSL after completion of the works, affecting residences on the eastern bank of Clanwilliam Dam (Smit, 2025)

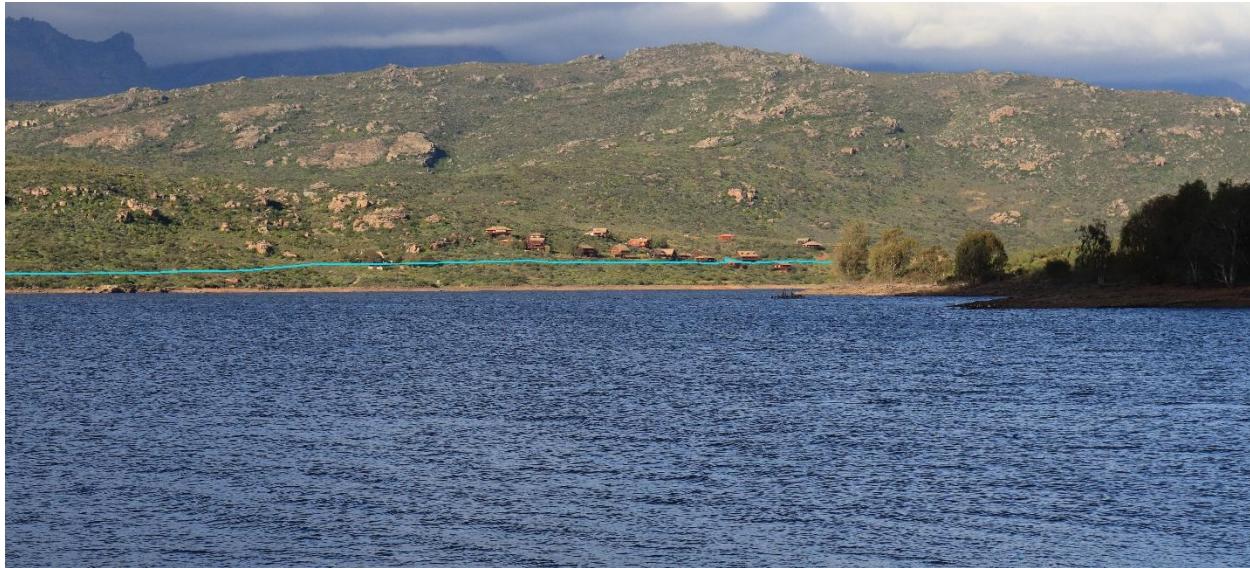
**Figure 26:** Diagrammatic simulation of the FSL after completion of the works (approximate), affecting Caleta Cove (Smit, 2025)

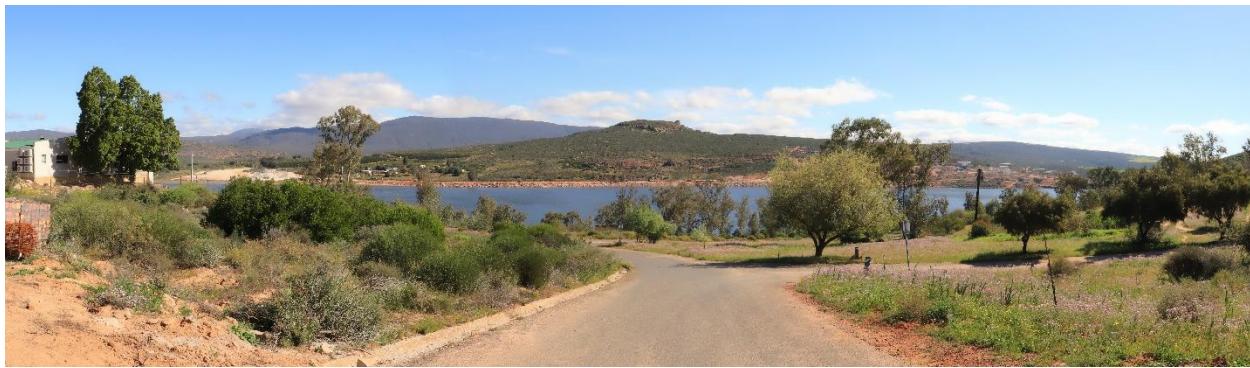
**Figure 28:** Site photograph to illustrate the extent to which vegetation plays a role in screening the Project from view, taken from the tarred road giving access to the municipal dam resort on the eastern bank. Note that the dam wall itself is not visible from this vantage point, but the construction activities and areas, including the crusher plant are clearly visible through breaks in the vegetation. (Smit, 2025)

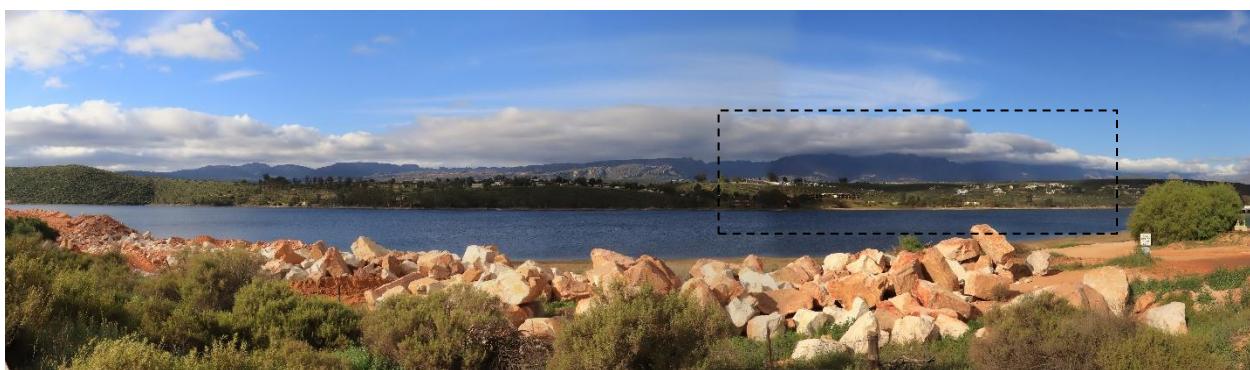
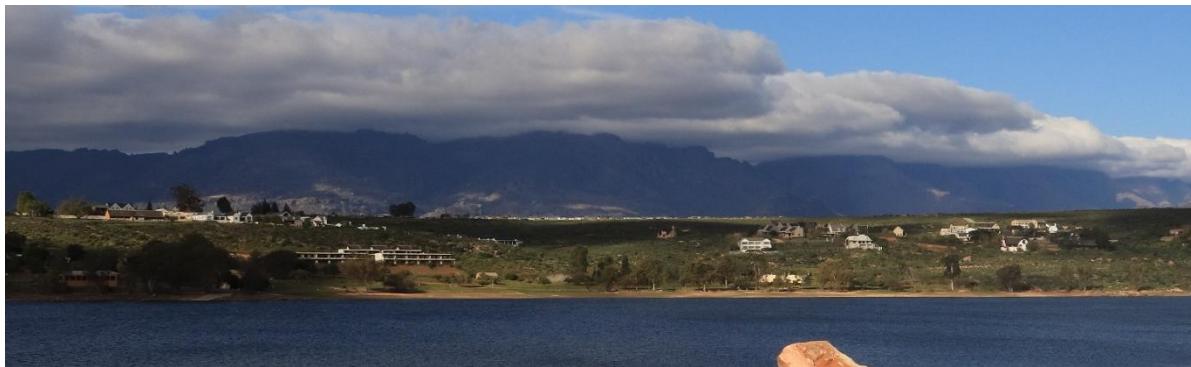
**Figure 29:** Site photograph illustrating the range and variety of viewers and viewer locations on the eastern bank from which the Project is visible. These include from left to right: Ramskop Nature Reserve, the municipal chalets, Clanwilliam Dam Resort, Clanwilliam Hills residential estate, informal residential area east of Ou Kaapse Road, Crystal Waters/Blue Waters residential estate. Yamu lifestyle resort and Caleta Cove are out of frame on the right. (Smit, 2025)

As shown in Figures 29, 30 and 31, planting trees along the eastern shore of the dam will not effectively screen views for most sensitive receptors, many of which are located at higher elevations than the tops of the tallest trees. Localised planting in key positions is a more effective method than restricting planting to the eastern shore alone. It would therefore be preferable to identify specific locations in need of screening with direct lines of sight and implement screening measures at those points.

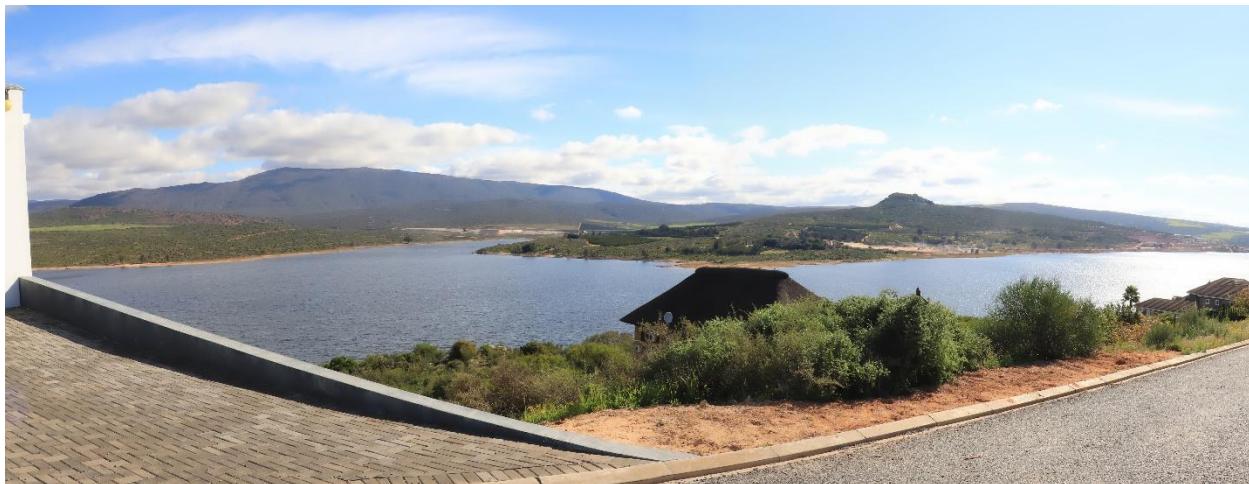
**Figure 30:** Site photograph taken from Willy Strassberger Dr within a small residential enclave on the eastern bank of the dam. This view is typical of views available from the Crystal Waters/Blue Waters estate. Note the lack of trees screening views over the dam at this elevation. (Smit, 2025)

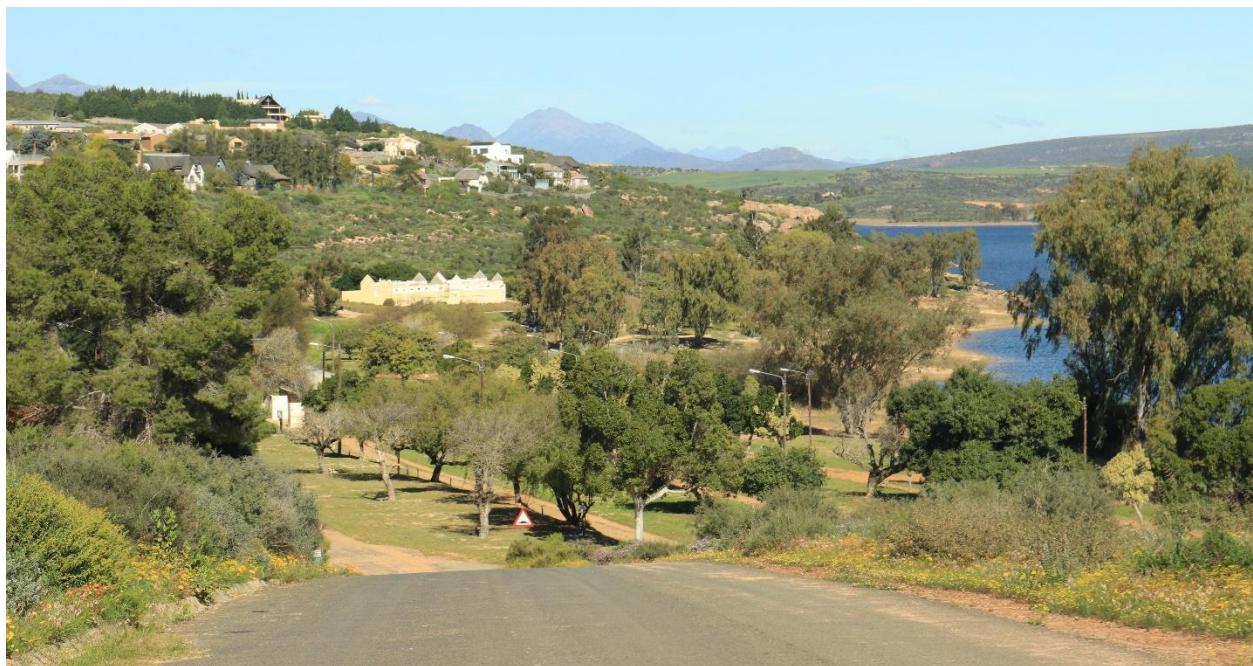
**Figure 31:** Site photograph illustrating the size and variety of existing trees within the Clanwilliam municipal dam resort, which will be inundated. Note also that the height of the existing trees at maturity play no role in screening for viewers in the residential areas. (Smit, 2025)

A particularly large number of mature trees occur within the municipal dam resort, representing a variety of species. The VIA did not explicitly note that the loss of these trees would significantly alter the sense of place, nor did it note the compounding the cumulative effect of losing a highly valued

recreational area long enjoyed by the public (see Fig. 31). Furthermore, the presence of drowned or decaying trees within the inundation zone will itself create a negative visual impact, which the 2006 VIA neither identified nor addressed through mitigation.

**Additional recommendation:** It is recommended that these trees be felled prior to inundation and either left in place or processed into chip or mulch for use elsewhere. This measure would not only avoid negative visual impacts but also reduce potential safety hazards such as floating debris. Given the cumulative recreational, social and heritage value of the municipal resort, proactive mitigation of tree loss is warranted.

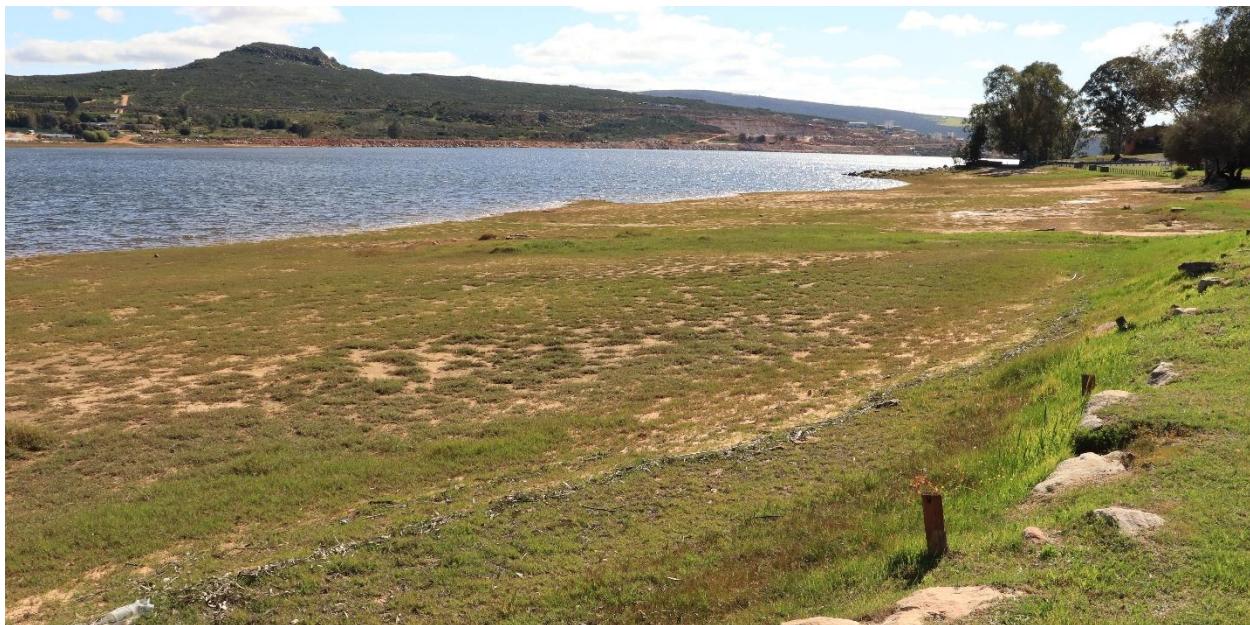
**Figure 32:** Site photograph of the existing inundation fringe zone during winter, showing relatively continuous cover by low growing grass species. Note also the debris indicating a recent high-water mark, suggesting that these species tolerate inundation for periods of time. (Smit, 2025)

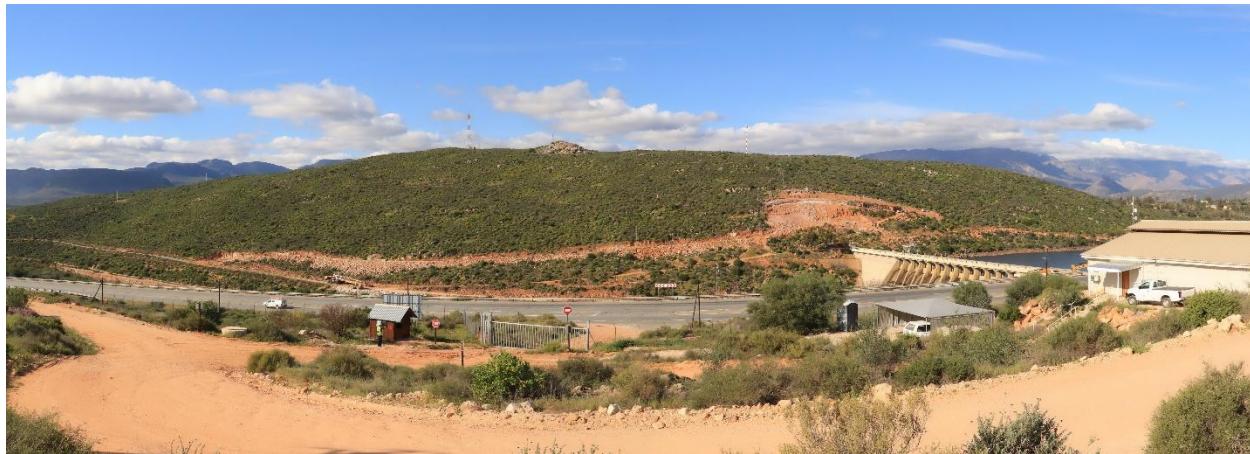
**Figure 33:** Site photograph illustrating areas of disturbance on the eastern bank associated with the dam wall raising. Note the increased visibility of the road cutting sans vegetative rehabilitation of the road embankment. (Smit, 2025)

- All areas subject to cutting, filling, or bulk earthworks must be regraded to a stable slope that imitates the fall of surrounding landforms.
- Topsoil must be reinstated after grading, in accordance with the botanist's or rehabilitation plan's specification. Where topsoil was not stockpiled correctly or at the right time (e.g.; prior to construction), it must be sourced sustainably from elsewhere.
- The rehabilitation plan must account for soil type, slope, aspect, elevation, and other site-specific conditions that influence vegetation type and composition.
- Revegetation must occur over a prolonged period (3–5 years minimum) with active monitoring, to ensure correct species mixes are established and alien invasive species are

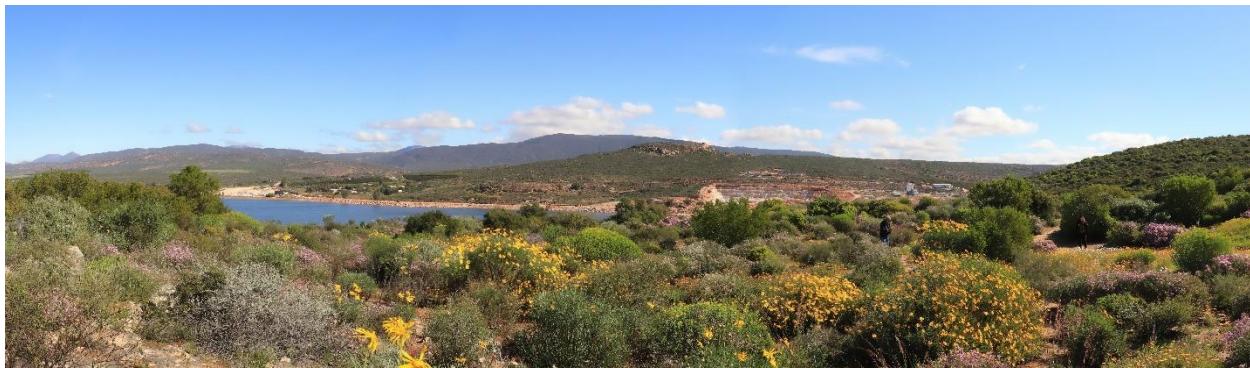
**Figure 34:** Site photograph taken from the Ramskop Nature Reserve illustrating the visibility of disturbed areas from pathways within this highly valued facility. Notice especially the visibility of the quarry, which is located within approximately 800m of the viewer. (Smit, 2025)

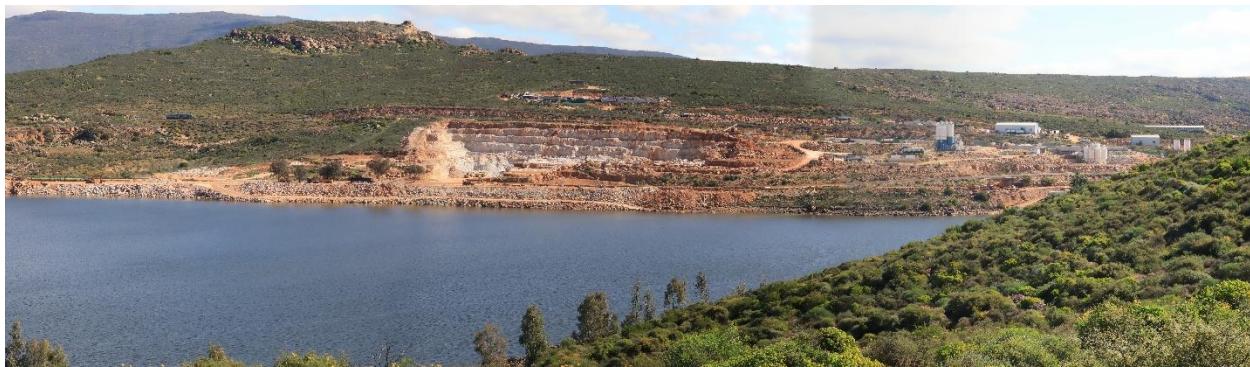
**Figure 35:** Enlarged site photograph of the quarry and parts of the construction site areas visible from the slopes of the hill surrounding the Ramskop Nature Reserve (Smit 2025)
