# FILIA VISUAL

## **VISUAL STATEMENT FOR THE CLANWILLIAM DAM RAISING PROJECT**

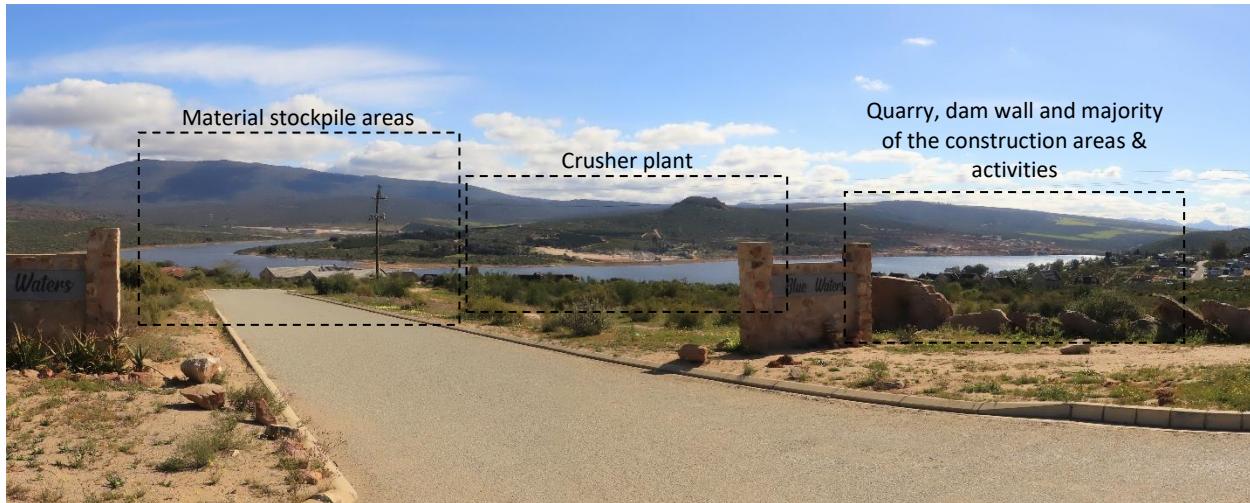
Figure 1: Site photograph illustrating the extent of the Project on the western bank of Clanwilliam Dam (Smit, 2025)

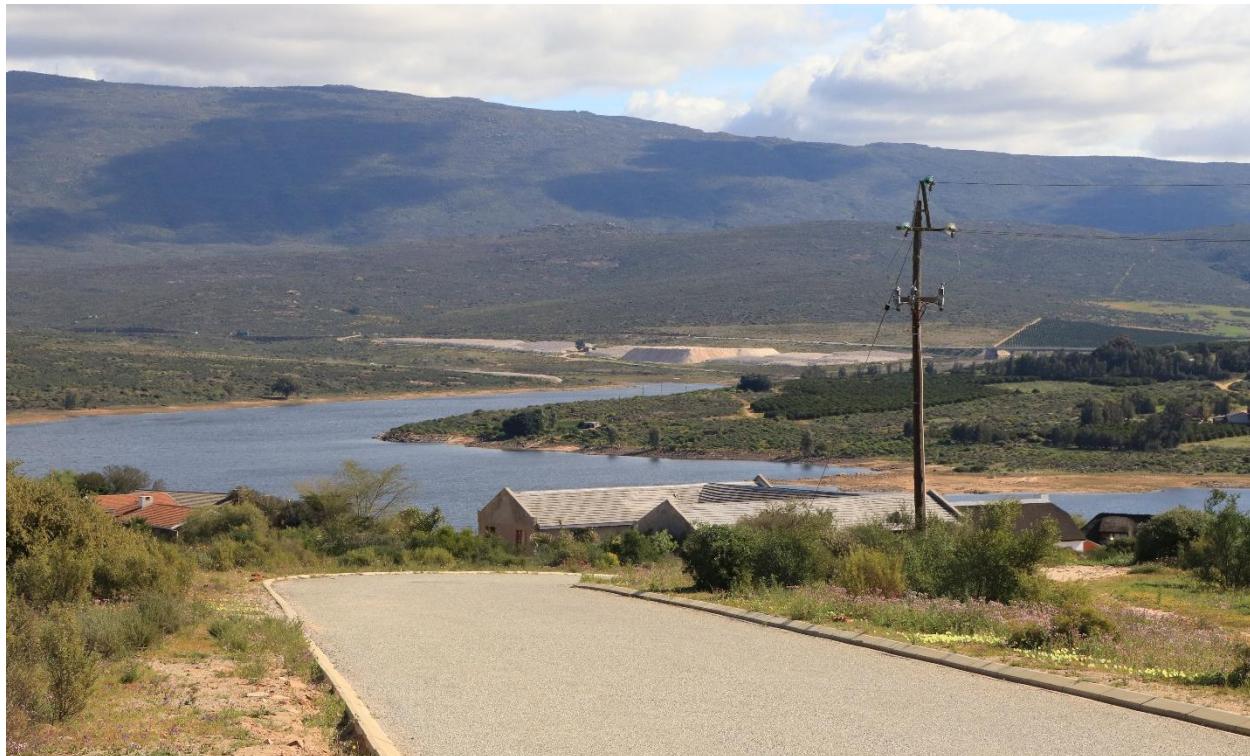
Figure 2: Enlargement of Figure 1 above, showing material stockpile areas (Smit, 2025)

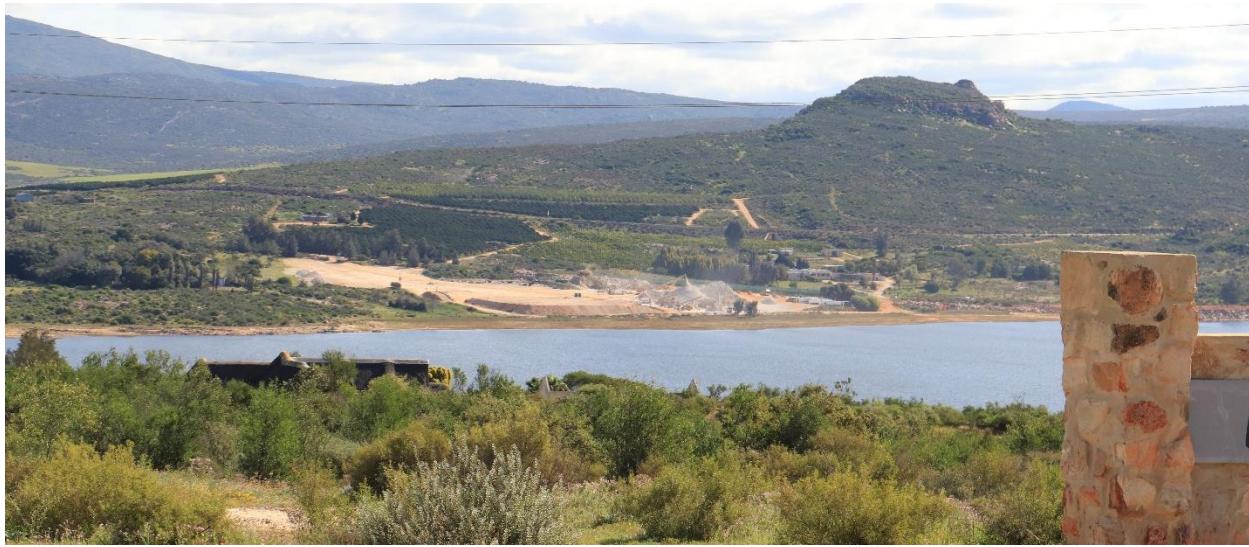
**Figure 3:** Enlargement of Figure 1 above, showing crusher plant and materials screening area (Smit, 2025)

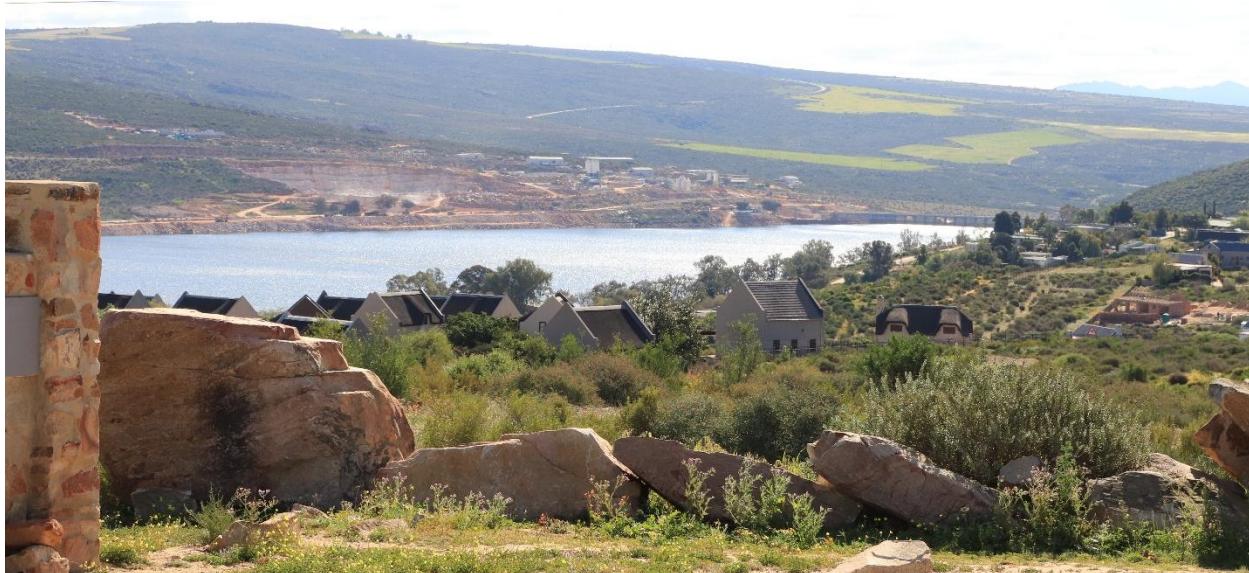
**Figure 4:** Enlargement of Figure 1 above, showing the extension to the quarry, the dam wall and the majority of the construction activities and areas visible on the western bank (Smit, 2025)

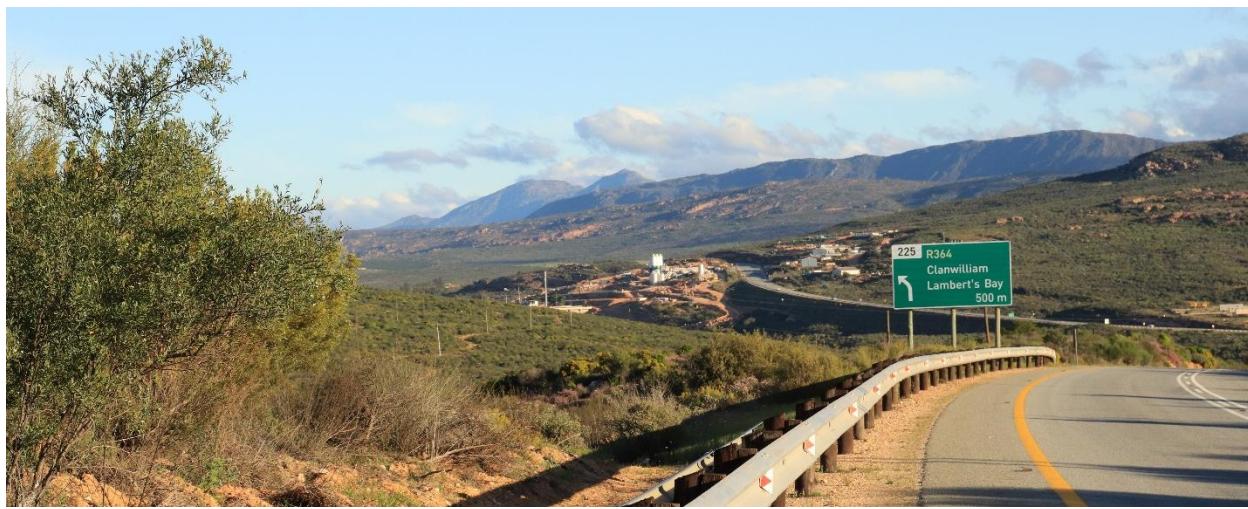
**Figure 5:** View of the construction areas on the western bank as viewed from the N7, looking south (Smit, 2025)

In contrast, the construction activities associated with the raising of the dam wall are considerably more visually intrusive and carry stronger negative associations from a viewer perception perspective. As construction began in 2013, these impacts can already be regarded as long-term. This suggests that tree planting, if required, would have been far more effective as a mitigation measure for construction-related disturbance rather than for the dam wall itself. Had the visual specialists at the time anticipated the true duration and extent of construction activities, they may have recommended immediate tree planting to help mitigate visual disturbance during or even before the construction phase.

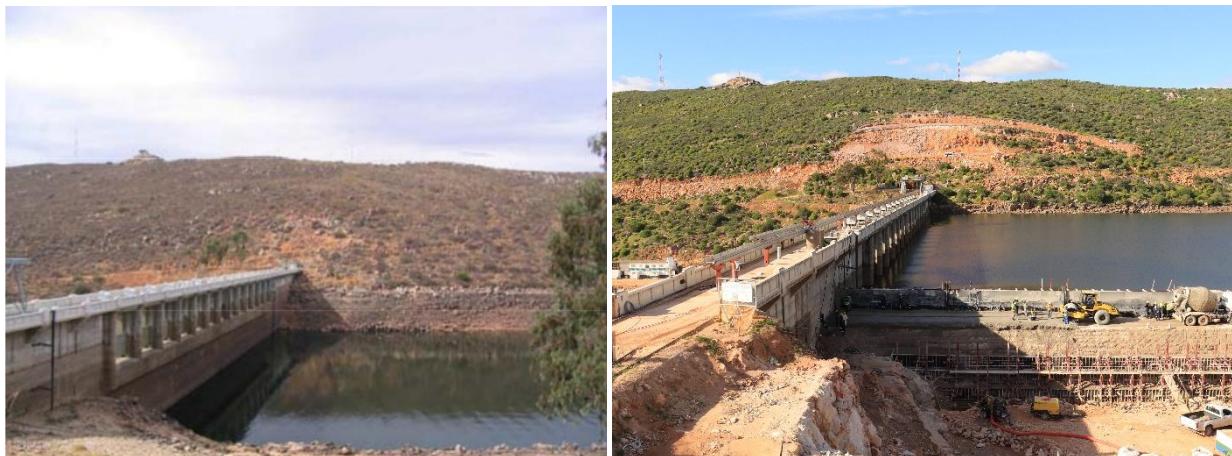
As indicated in the RFQ, the scope of this specialist opinion includes determining whether the raised dam wall itself should be considered visually intrusive. One of the original conditions suggests that visual receptors along the eastern shore would perceive the upstream face of the dam wall as visually unappealing, and this issue requires clarification.

**Figure 9:** Comparative image of Photo 2, showing a view of the upstream face of the dam wall, looking northeast (Ninham & Shand, 2009 and Smit, 2025)

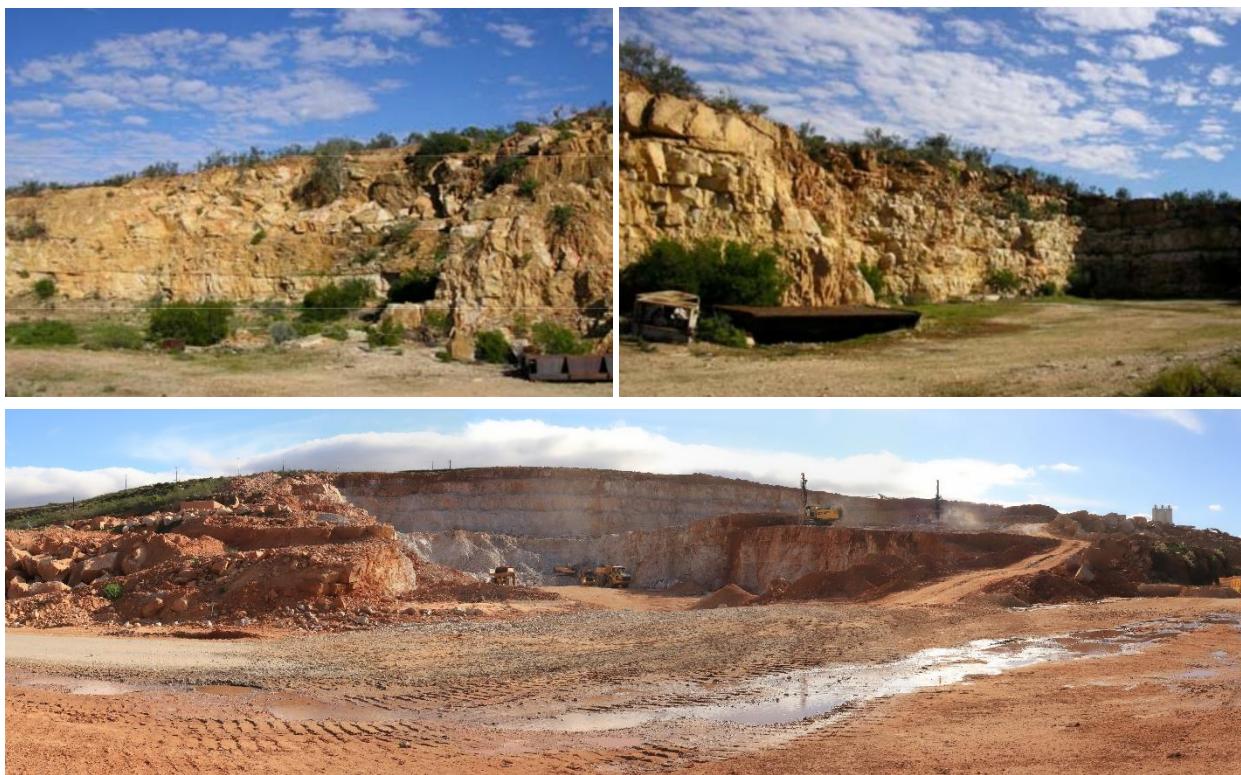
**Figure 10:** Comparative image of Photo 3 and 4, showing a view of the existing and extended quarry to the west of the dam wall (Ninham & Shand, 2009 and Smit, 2025)

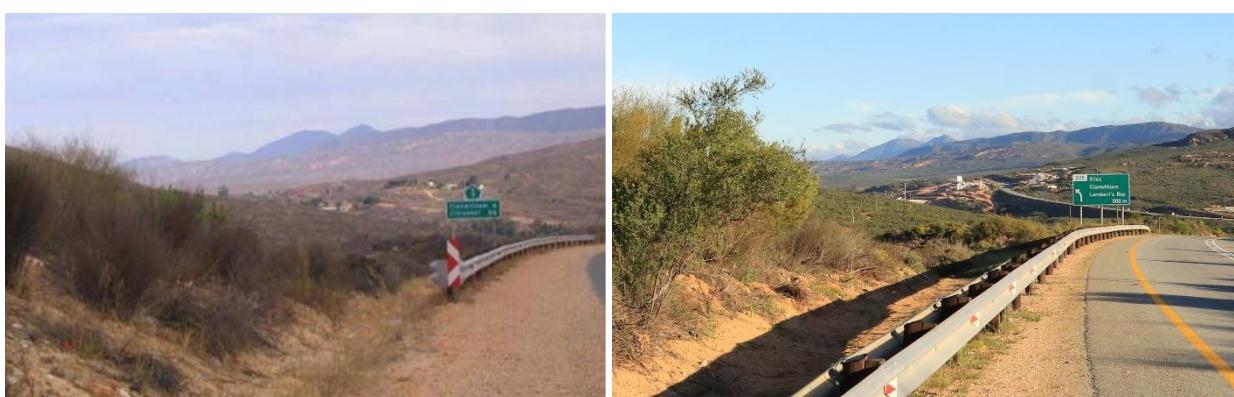
**Figure 12:** Comparative image of Photo 6, showing a view 2.5 km north of Clanwilliam Dam, viewed from the N7. The dam wall is visible but not noticeable. (Ninham & Shand, 2009 and Smit, 2025)

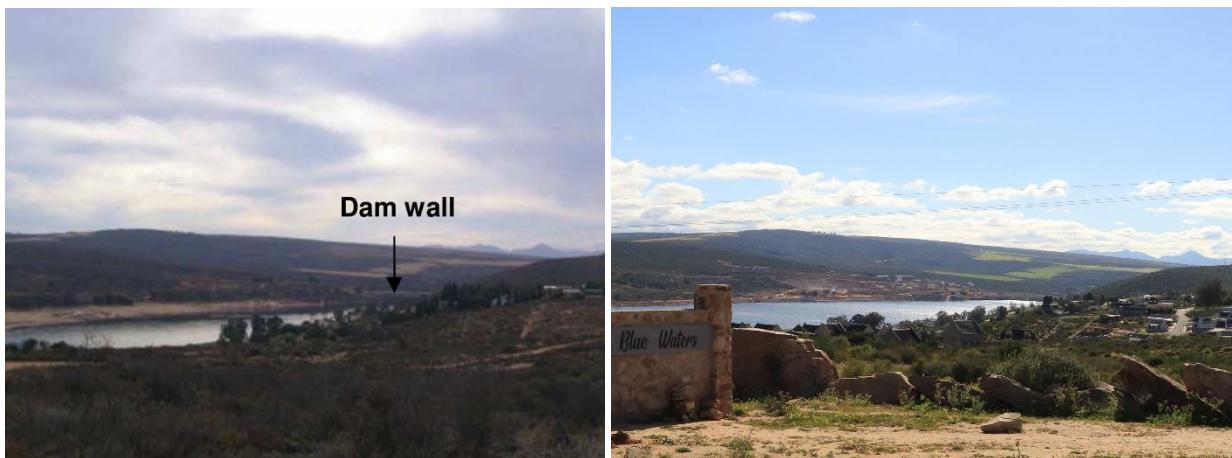
**Figure 14:** Comparative image of Photo 8, showing a view of the dam wall from the eastern bank, 2-3 km upstream of the wall. Dam blends into surroundings. (Ninham & Shand, 2009 and Smit, 2025)

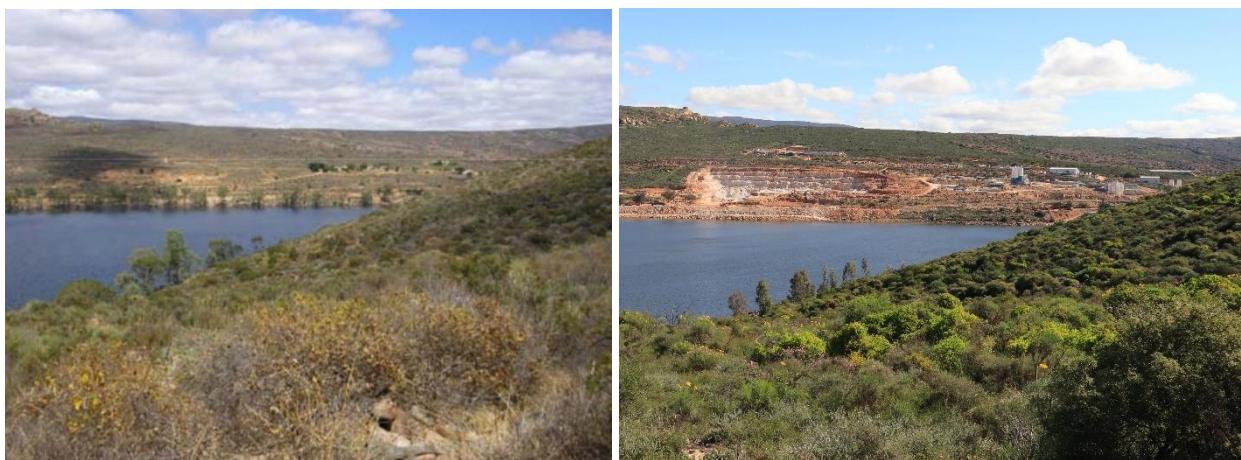
**Figure 17:** Comparative image of Photo 12, view from Ramskop Nature Reserve of the existing quarry (Ninham & Shand, 2009 and Smit, 2025)

The Ramskop Nature Reserve, although mentioned in the VIA, does not appear in the receptor list, and none of the mitigation measures explicitly address potential visual impacts on this highly valued community facility, which is itself a scenic asset. All of these receptors are subject to long-term visual disturbance resulting from the Project. Tree-planting conditions should therefore apply more broadly and include all sensitive receptors with direct line of sight<sup>3</sup> to the Project's visual elements.

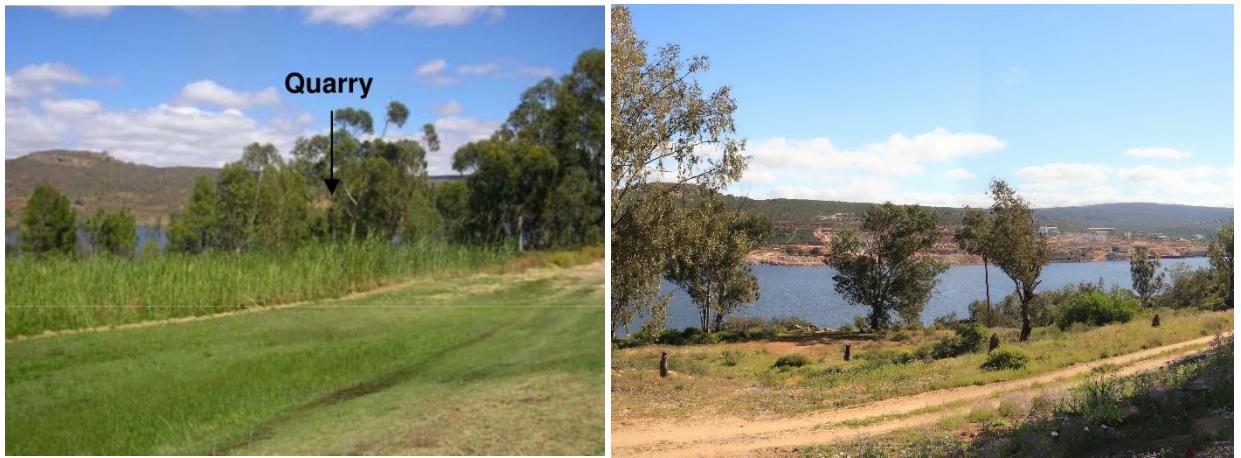
**Figure 18:** Comparative image of Photo 13, showing a view from Clanwilliam Municipality Dam Resort chalets towards quarry and N7, which is largely screened by vegetation (Ninham & Shand, 2009 and Smit, 2025)

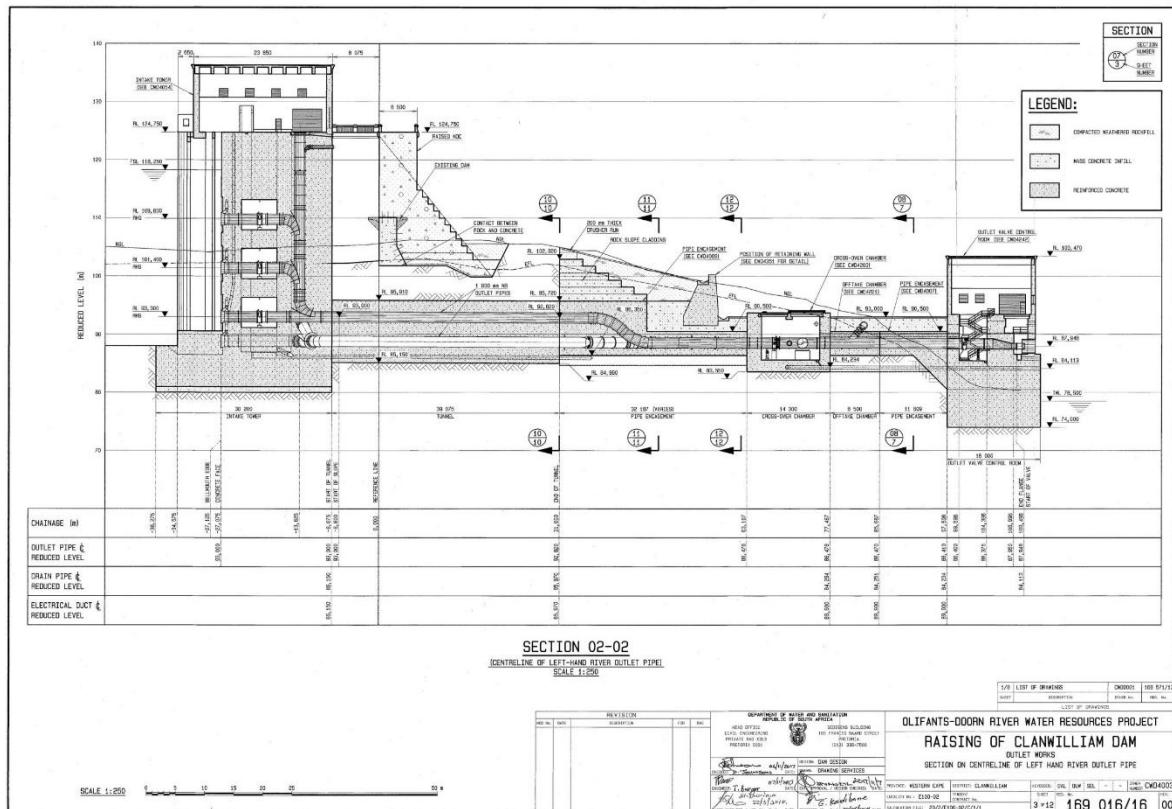
Figure 22: Section 02-02, showing total height of the dam as well as the (significantly taller) intake tower (Department of Water and Sanitation, 2017)

It should be noted that the VIA does not make mention of the intake tower illustrated in Figure 23 above. This structure, although it does not raise the overall level of the dam wall, was either not part of the design at the time of the writing of the VIA, or it was overlooked as a visible element requiring mitigation. See Condition 1 & 2 for further detail.

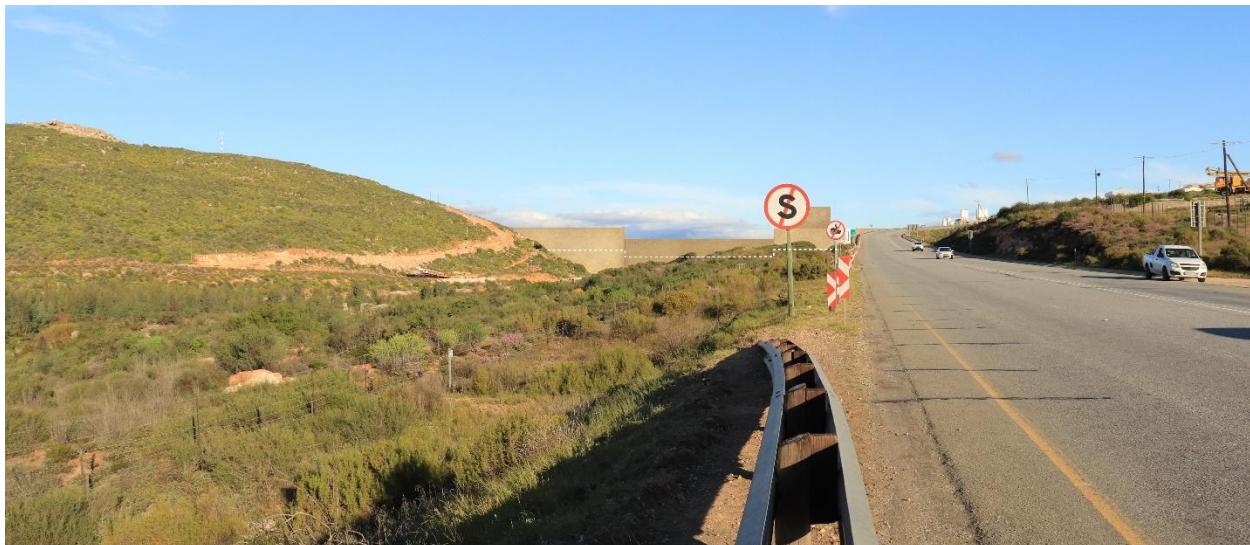
*Figure 27: Simulation of the proposed dam wall as viewed from the N7 for commuters travelling south (Smit, 2025)*
